U.S. Department of Transportation

National Highway Traffic Safety Administration

Case Veh. (A): 1998 Plymouth

Type: Neon, 4-door sedan Driver: 31-year-old female

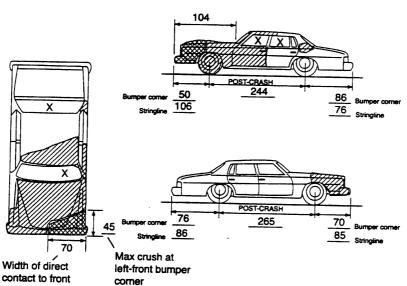
#### MEASUREMENTS IN CENTIMETERS

(Slide 4) Damage to case vehicle (A) was moderate. (Slide 5) Direct damage began at the left-front bumper corner and extended 70 cm to the right, resulting in a vehicle overlap of 49 percent. (Slide 6) The maximum crush was 45 cm at the left-front bumper corner.

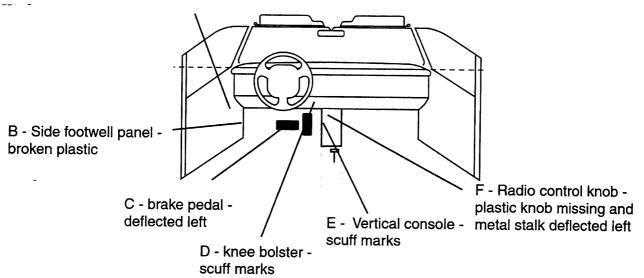
### VEHICLE OCCUPANT CONTACT DIAGRAM

Confidence
	Interior	Occupant	Body		Level of
	Component	No. if	Region		Contact
Contact	Contacted	Known	if Known	Supporting Physical Evidence	Point
Α	Lt. door	Driver	Left thigh	Bowed outward	1
	Footwell	Driver	Lt. leg	Cracked and broken plastic	1
В	panel			_	
С	Brake pedal	Driver	Rt. ankle	Deflected left	1
D-	Knee bolster	Driver	Rt. leg	Scuff mark	1
_	Vertical	Driver	Rt. leg	Scuff mark	1
E	console				
_	Radio knob	Driver	Rt. leg	Plastic knob knocked off and	1
F		_		metal stalk deflected left	
G					
Н					
ı					
J

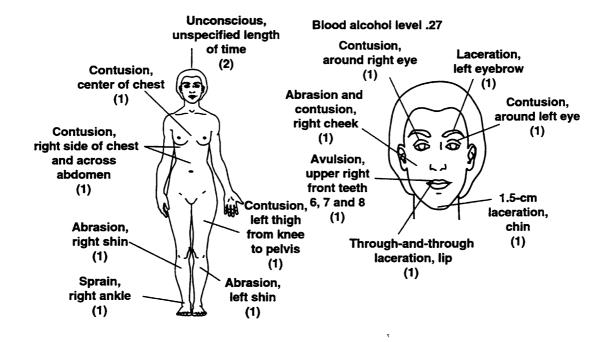
#### INDICATE LOCATION OF INJURIES.

,		Injury Source		
Injury Description	A.I.S.	Definite	Probable	Possible
Laceration, left eyebrow	1		Eyeglasses (airbag interaction)	
Contusions, around right and left eyes	1		Eyeglasses (airbag interaction)	
Abrasion, right cheek	1		Airbag	
Contusion, right cheek	1		Airbag	
Unconscious, unknown length of time	2		Side-door interior surface	A-pillar
Avulsion, upper right front teeth 6th, 7th and 8th	1		Side-door interior surface	A-pillar
Through-and-through laceration, lip	1		Side-door interior surface	A-pillar
1.5-cm laceration, chin	1		Side-door interior surface	A-pillar
Contusion, center of chest	1		Airbag	
Contusion, right side of chest	1		Airbag	
Contusion, across abdomen	1		Lower steering-wheel rim	Airbag
Contusion, left thigh from knee to pelvis	1		Side-door interior surface

Injury Source		
Injury Description	A.I.S.	Definite	Probable	Possible
Abrasion right shin	1		Knee bolster	Vertical console/radio control knob
Abrasion, left shin	1		Side footwell panel	
Sprain, right ankle	1		Brake pedal	Toepan
Blood alcohol level .27				
Maximum A.I.S. Level	<u>2</u>			
Injury Severity Score	<u>6</u>
